### Minerals Inspection Report

Mine Name: Bates Knoll	Permit Number: S/047/0110	Mine Status: Active
Operator Name: Wilkenson Construction	Inspection Date: 06/25/2013	Permit Fees: Paid
Inspector(s): A. Abate	Inspection Time: 1:00 PM	Bond Amount: \$27,700.00
Attendee(s): David Cox	Weather: Clear 70s	Bond Escalation: 01/26/16
Inspection Purpose: Routine inspection		Prior Inspection: None

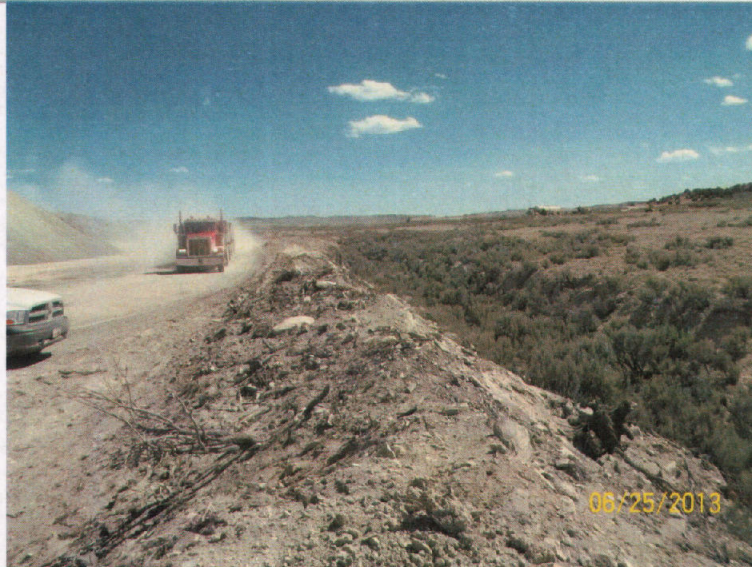
Berm located along the west boundary of the site. The drainage to the west essentially bounds the property. No backfill from the site disturbance was observed in the drainage.

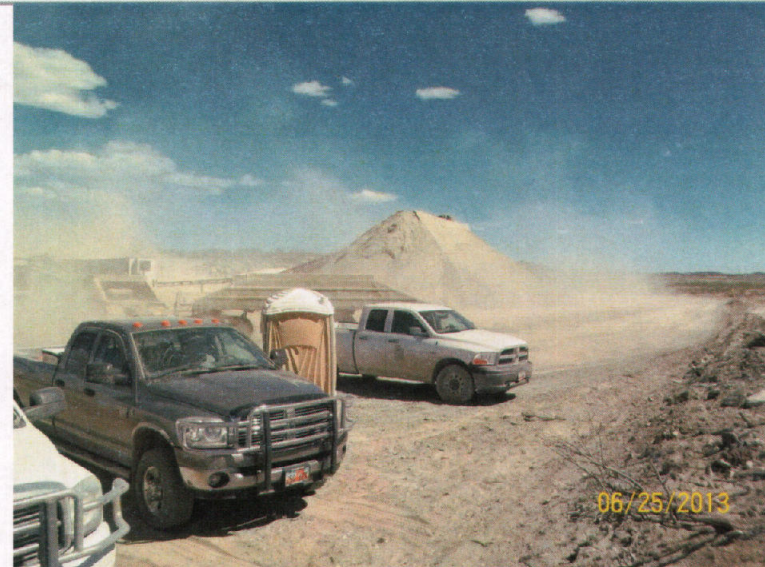
Active mining and stockpiling was occurring at the site during the inspection. The activity was kicking up lots of dust.

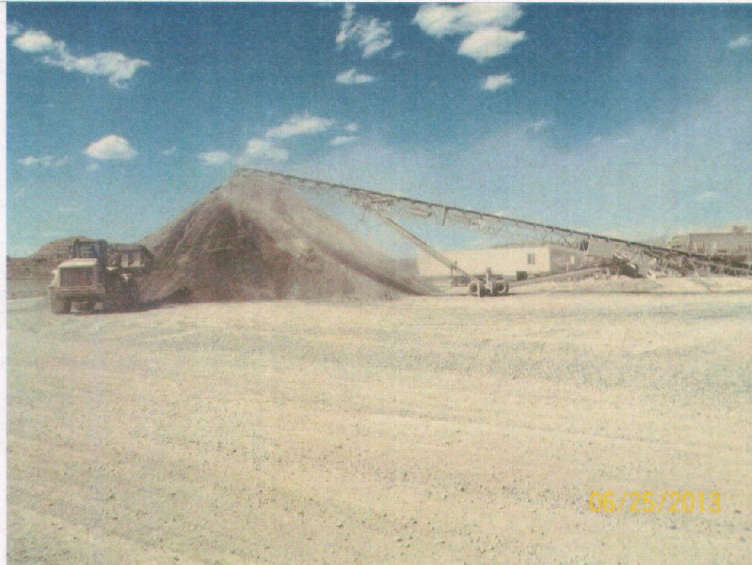
Main stockpile

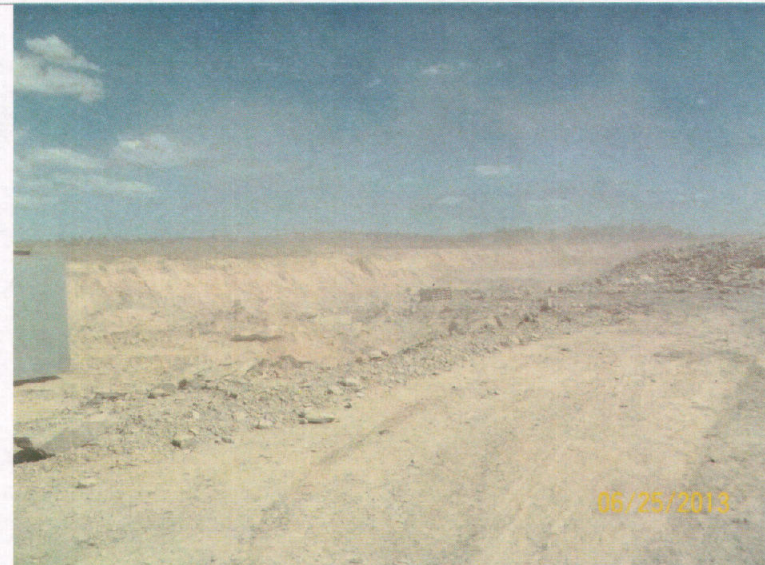
This road led to the active quarrying area.
